**Flood Control Project Maintenance
Levee Inspections**

2018 Channel Summary Report

Tehama County Fld Control & Water Cons Dist

Flood Control Project Maintenance**Unit Cover Sheet****2018 Channel Inspection Results****Tehama County Fld Control & Water Cons Dist**

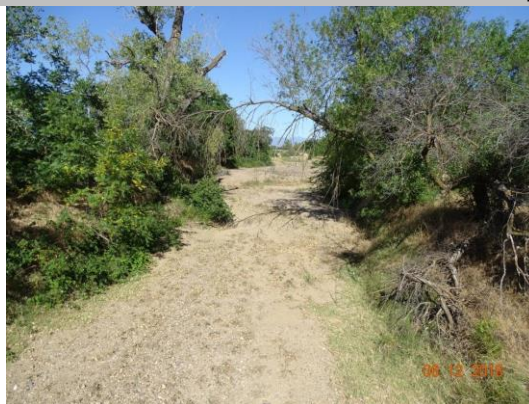
Photo 1 of 1 : CH_2018_NA0019_3_1_20180618_00008.jpg

Rating **	A	Issue No.	1	GPS Lat/Long
Issue Type +	Ma	Location *		40.009840 °
Category	Rivers, Channels & Designated Flood			-122.200180 °
Item	Vegetation & Obstructions			
DWR ID	DWR_NA0019_3_c_2012_1			
Action/Comments				
Inspector Comments: No vegetation in the channel.

View of the upstream extension of McClure Creek at Truckee Avenue.

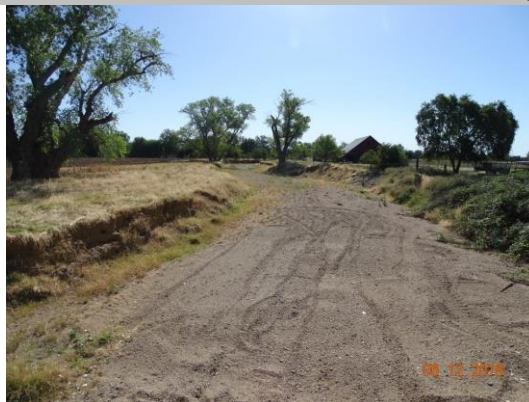
Photo 1 of 1 : CH_2018_NA0019_3_6_20180618_00009.jpg

Inspector Comments: No vegetation in the channel.

View of the downstream extension of McClure Creek at Truckee Avenue.

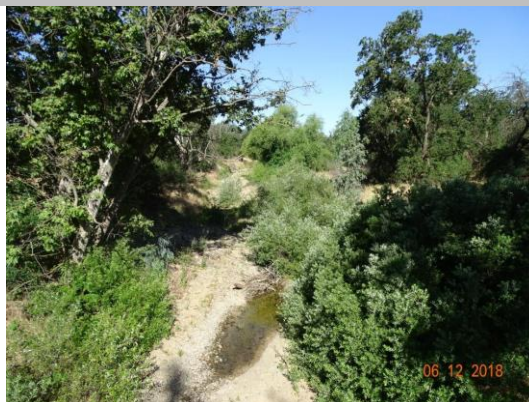
Photo 1 of 1 : CH_2018_NA0019_3_11_20180618_00010.jpg

Upstream view from Highway 99W. Note the vegetation in the channel.

Check Point / View				
Highway 99 W / Up				
Rating **	M	Issue No.	11	GPS Lat/Long
Issue Type +	Ma	Location *		40.007430 °
Category	Rivers, Channels & Designated Flood			-122.171780 °
Item	Vegetation & Obstructions			
DWR ID	DWR_NA0019_3_c_2012_11			
Action/Comments				
Inspector Comments: Remove all vegetation from channel before winter.

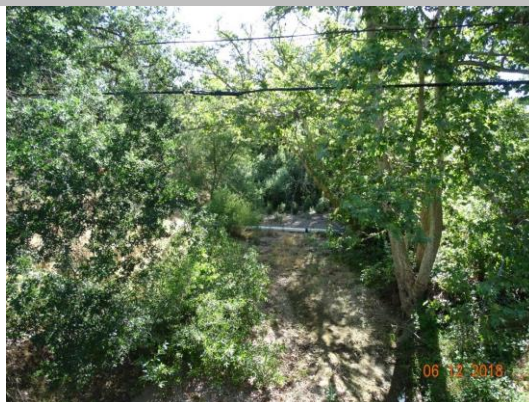
Photo 1 of 1 : CH_2018_NA0019_3_16_20180618_00011.jpg

Downstream view from Highway 99 W. There is an irrigation pipe going across the channel.

Inspector Comments: There is an irrigation pipeline going across the channel.

Rating **	M	Issue No.	16	GPS Lat/Long
Issue Type +	Ma	Location *		40.007430 °
Category	Rivers, Channels & Designated Flood			-122.171780 °
Item	Vegetation & Obstructions			
DWR ID	DWR_NA0019_3_c_2012_16			
Action/Comments				
Inspector Comments: Remove the irrigation pipe and all vegetation from channel before winter.

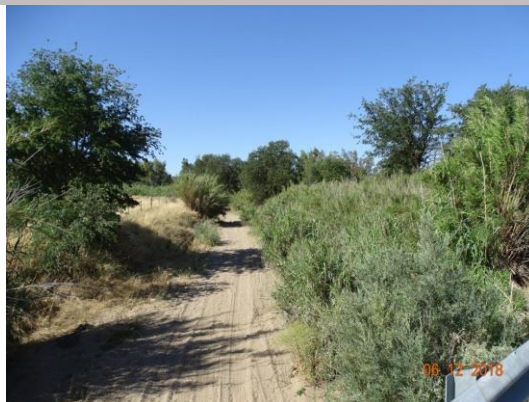
Photo 1 of 1 : CH_2018_NA0019_3_41_20180618_00014.jpg

Upstream from Hamilton Road. Dense vegetation in the channel.

Inspector Comments: Remove all vegetation from the channel before winter. Arundo should be eradicated.

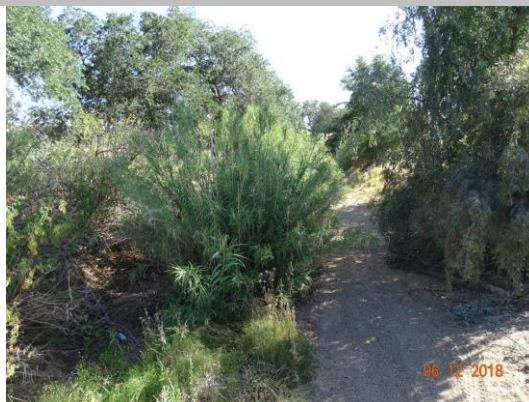
Photo 1 of 1 : CH_2018_NA0019_3_46_20180618_00013.jpg

Downstream from Hamilton Road. Dense vegetation in the channel.

Inspector Comments: Remove all vegetation from the channel before winter. Arundo should be eradicated.

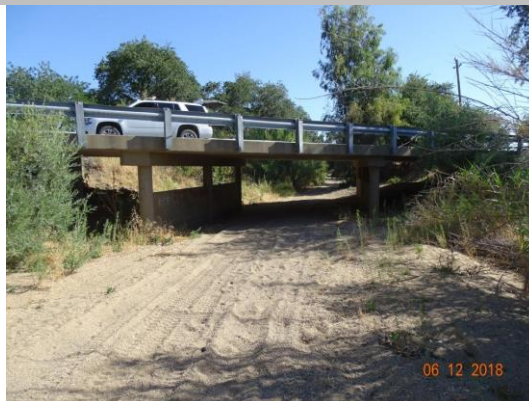
Photo 1 of 1 : CH_2018_NA0019_3_50_20180618_00012.jpg

There is no significant debris in the channel.

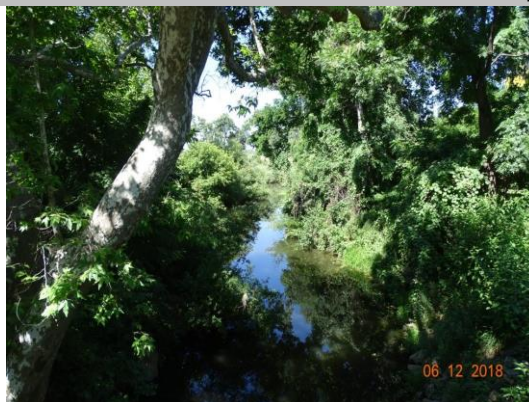
Photo 1 of 1 : CH_2018_NA0019_4_1_20180625_00007.jpg

Rating **	A	Issue No.	1	GPS Lat/Long
Issue Type +	Ma	Location *		40.157120 °
Category	Rivers, Channels & Designated Flood			-122.164250 °
Item	Vegetation & Obstructions			
DWR ID	DWR_NA0019_4_c_2012_1			
Action/Comments				
Inspector Comments: Minimal, scattered obstructions or vegetation. The flow is not impeded.

Upstream view of Salt Creek from the railroad car bridge.

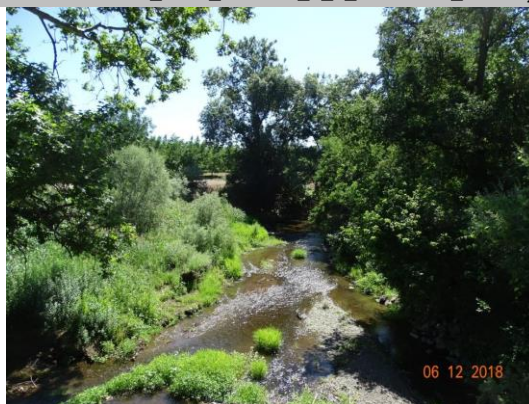
Photo 1 of 1 : CH_2018_NA0019_4_6_20180625_00009.jpg

Inspector Comments: Minimal scattered obstructions or vegetation. The flow is not impeded.

Downstream view of salt Creek from the railroad car bridge.

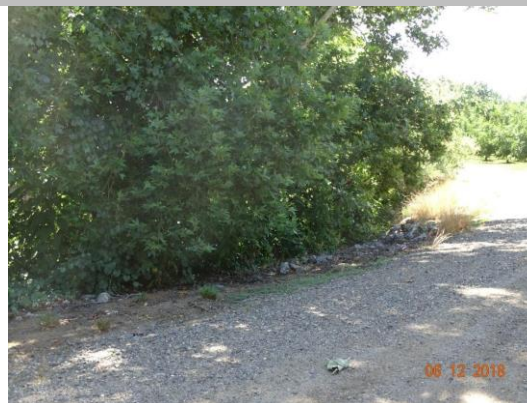
Photo 1 of 1 : CH_2018_NA0019_4_14_20180625_00010.jpg

Inspector Comments: Existing riprap protection is properly maintained and is undamaged. Riprap clearly visible.

The landowner has placed rip rap along all erosion sites.

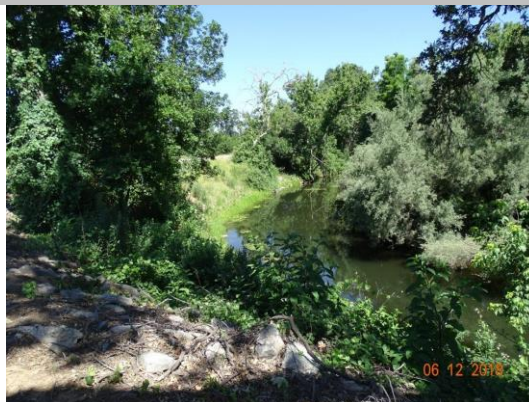
Photo 1 of 1 : CH_2018_NA0019_4_21_20180625_00011.jpg

Channel has been cleared of logs and vegetation by landowner.

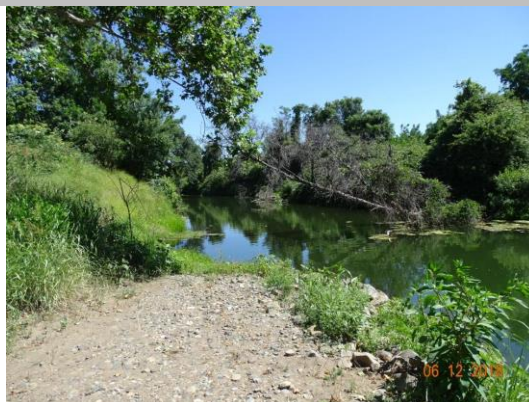
Photo 1 of 1 : CH_2018_NA0019_4_31_20180625_00012.jpg

Upstream view of Salt Creek from the confluence of the Sacramento River.

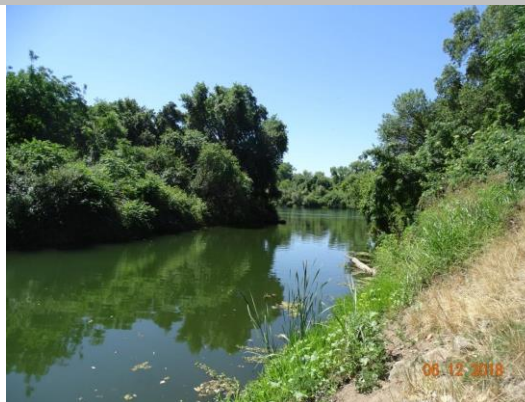
Photo 1 of 1 : CH_2018_NA0019_4_36_20180625_00013.jpg

Inspector Comments: Minimal, scattered obstructions or vegetation. The flow is not impacted.

Downstream view of the confluence of the Sacramento River.
